Case study

Monitoring solution for car parks (Repair)

New car park project

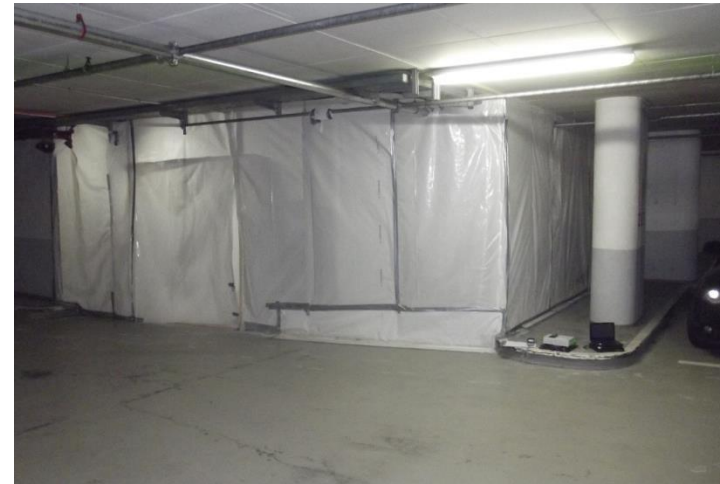
As a result of high loads (mechanical / chloride), damage (cracks / spalling) became visible on the floors of the underground car park. In order to get an exact picture of the damage, the underground car park was inspected, and the damage was catalogued. The client commissioned a trial repair to verify the repair calculation and to determine a repair technology appropriate to the object and the damage. The "W" repair principle was to be used, as well as the removal of salts from the columns. Moisture and corrosion monitoring systems from BS2 were used as a safeguard.

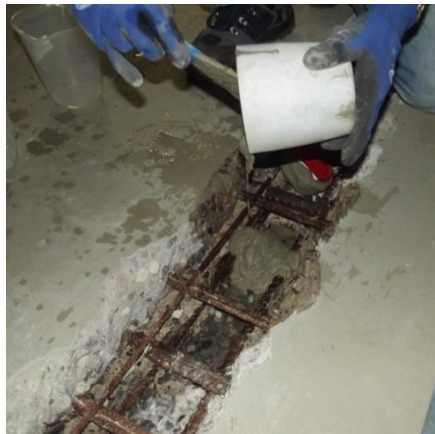
corroDec[®]
2G

Installation of humidity and corrosion sensors (standard version) in the Crack area of the construction joint. Connection to the old concrete by means of coupling mortar

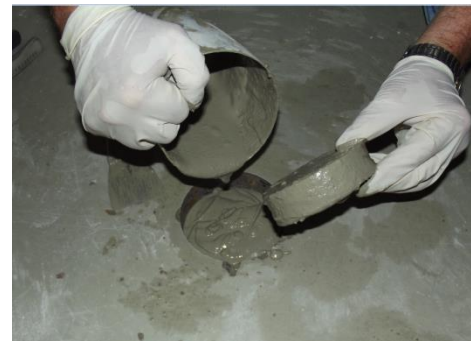
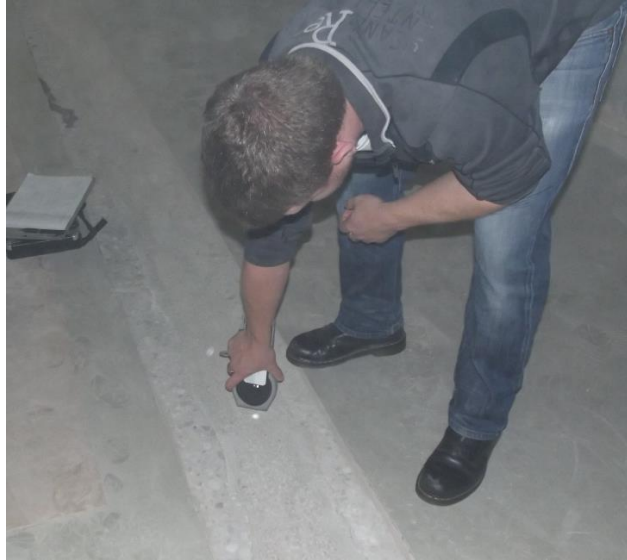
Installation of humidity sensors in the unloaded area (reference) of a pitch, as well as in the repair area

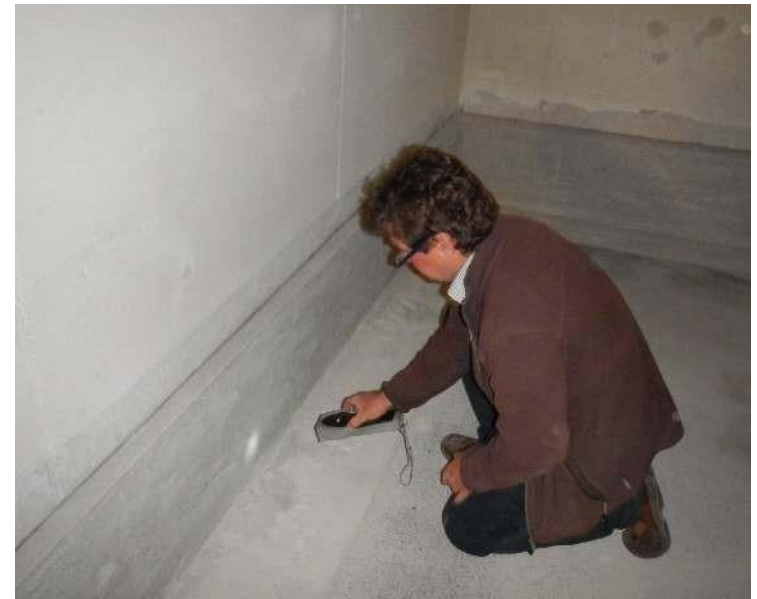
corroDec®
2G

The data was read out manually by a handheld reader, whereby the selection of the readers (10 cm / 30 cm) must correspond to the installation depths of the sensors. In addition, remote interrogation of the sensors is possible, e.g., to control the inspection periods.
